Service Bulletin

Subject: MILKY SUBSTANCE ON OIL LEVEL GAUGE (DIPSTICK)	Bulletin No: 01-050/06
	Last Issued: 11/21/2006

2004-2005 RX-8

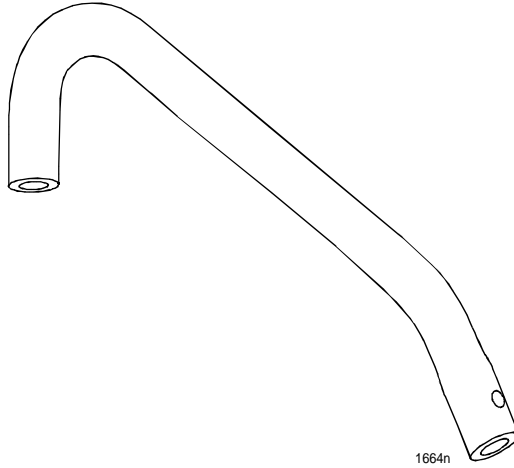
**DISCARD OLD HOSE FROM
BETWEEN INTAKE AIR HOSE
AND OIL FILLER PIPE**

3. Disconnect intake air hose from throttle body.

- Remove and discard the existing hose from between the intake air hose and the oil filler pipe.

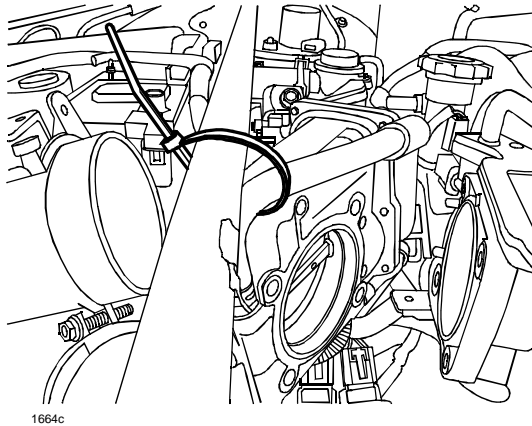
**DO NOT DISCONNECT THROTTLE
BODY HOSES-TIE WRAP THROTTLE
BODY TO BRACE AS SHOWN**

4. Remove throttle body bolts and tie-wrap throttle body to the strut tower brace.

- DO NOT disconnect the throttle body coolant hoses.
