Service Bulletin

Subject: HESITATION / IDLE VIBRATION DUE TO CRACKED ENGINE MOUNT	Bulletin No: 01-016/10
	Last Issued: 06/16/2010

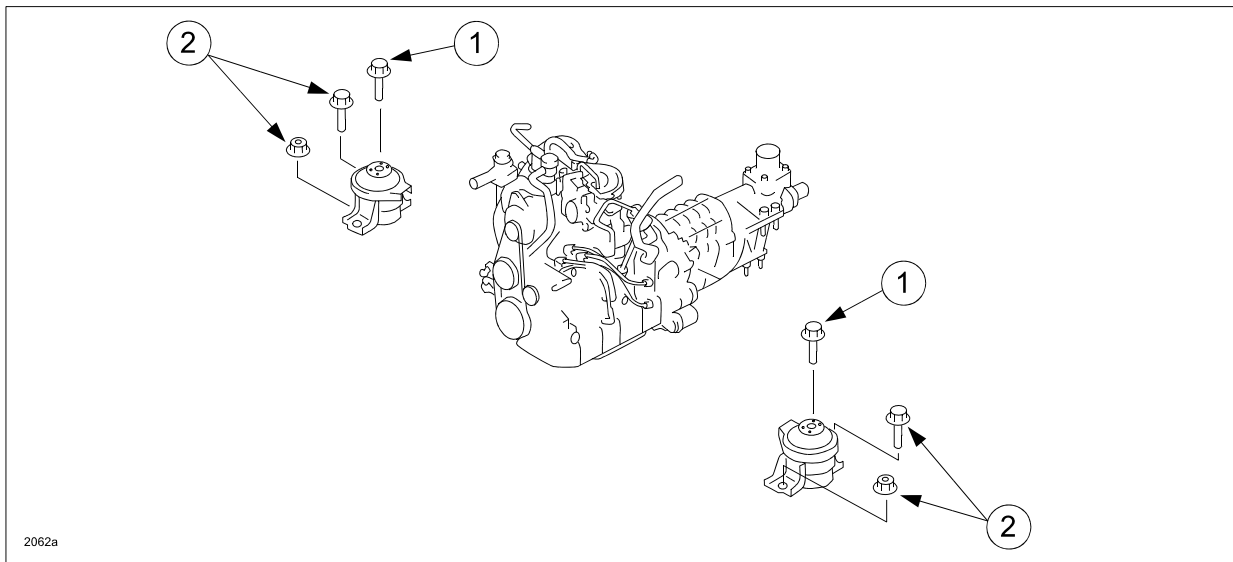
Depending on the driving condition or engine condition, the RH side engine mount rubber may deform. As a result, the RH side engine mount can crack. As a mass production change, the material of the engine mount rubber has been changed.

7. On RH side of engine, remove bolts/nuts in the following order:

- a. Engine mount bracket-to-engine mount (1).
Tightening Torque: 37-52 N.m (28-38 ft-lb)
- b. Engine mount-to-front sub frame (2).
Tightening Torque: 45-63 N.m (33-46 ft-lb)
