Bulletin No: 01-050/06 © 2006 Mazda Motor of America, Inc.	Last Issued: 11/21/2006
--	--------------------------------

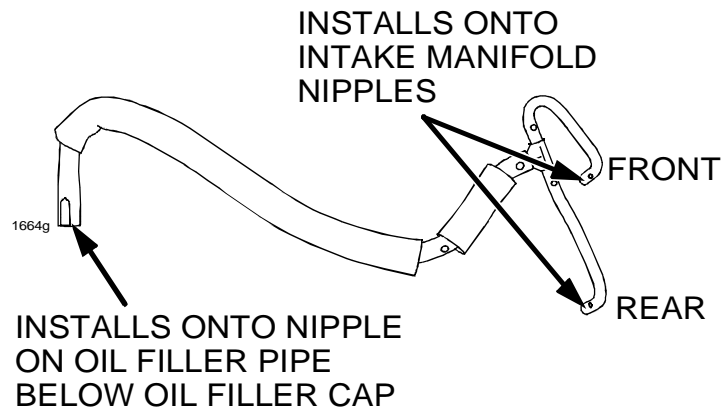
NEW PCV HOSE

23. Install new PCV hose to the engine. Plug the small vacuum lines into the lower intake manifold nipples as described.

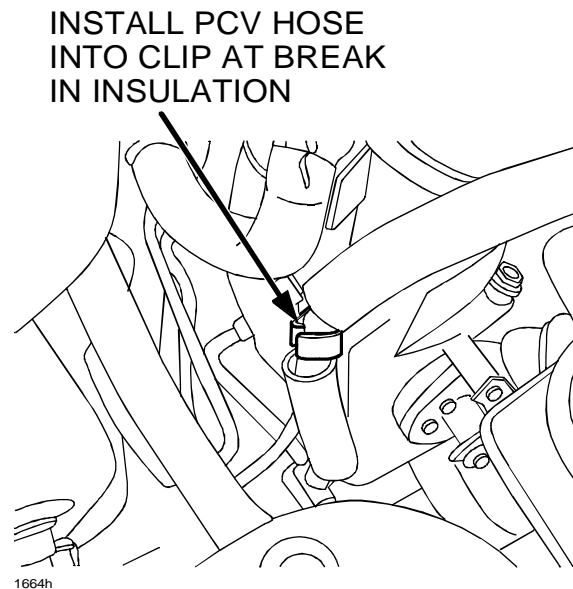
24. Route new PCV hose and through new clip at break in hose insulation.

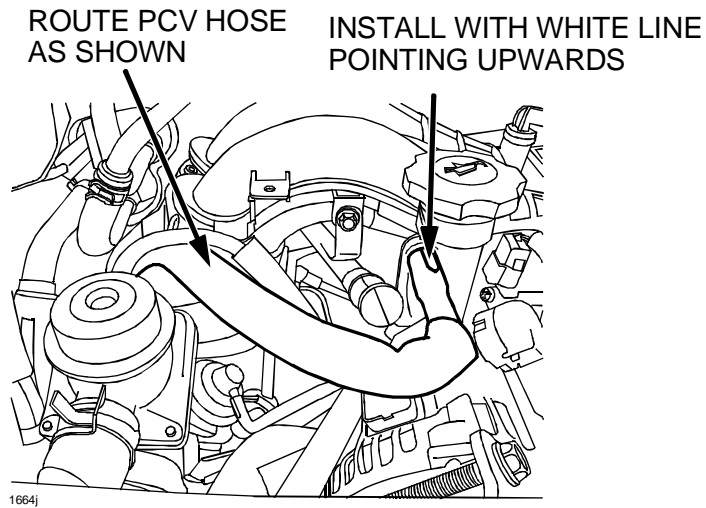
25. Route new PCV hose across engine and install into new oil filler pipe nipple with White line pointing upward.

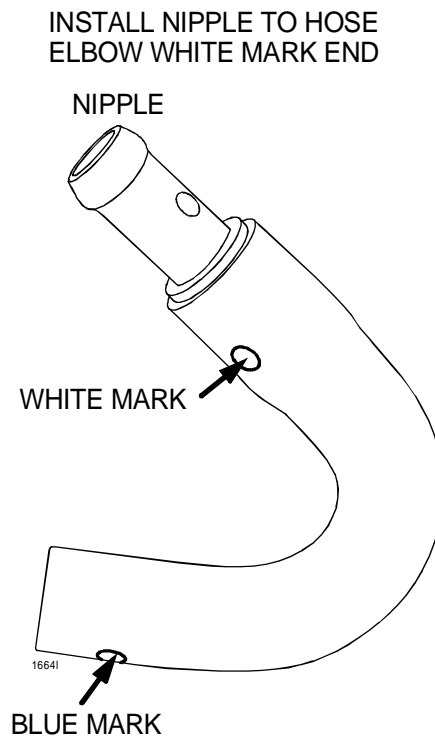
26. From the kit, install nipple into the White mark end of the elbow hose.

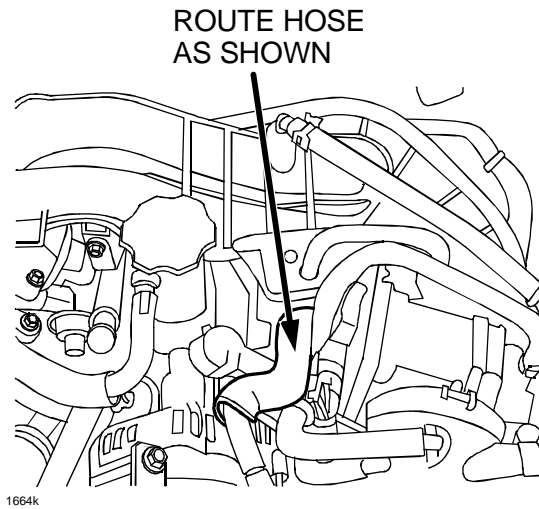
27. Route new PCV hose as shown.

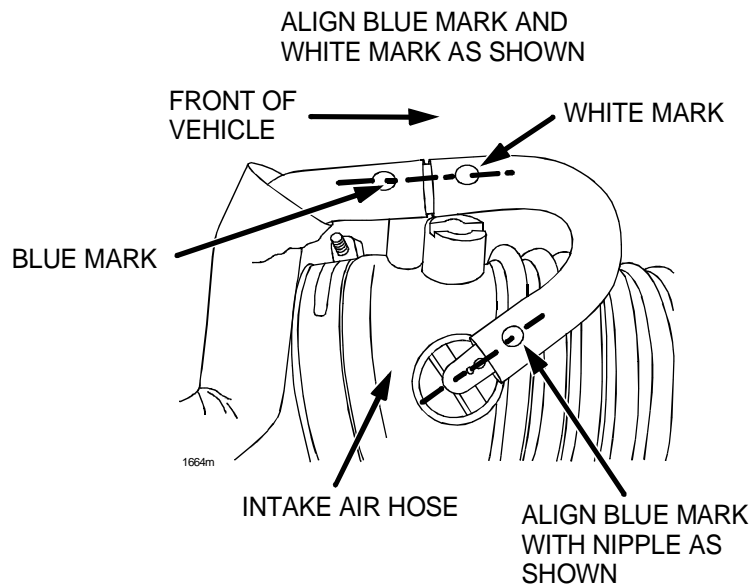
28. Connect new elbow hose to intake air hose nipple and insert nipple of new hose into new PCV hose as shown. Ensure marks are aligned properly.

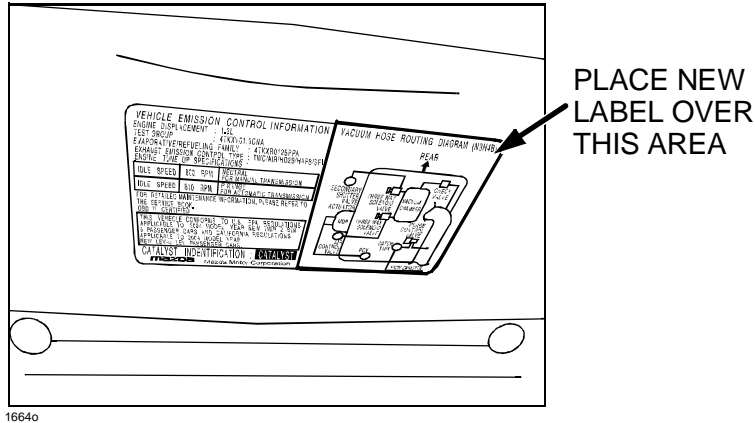
1664c

30. Clean existing under hood label and place new vacuum hose routing label over existing vacuum hose routing portion of label.

**INSTALL NEW VACUUM HOSE ROUTING
 DIAGRAM OVER EXISTING ROUTING
 DIAGRAM ON UNDER HOOD LABEL**
